# Manhole Inspection Summary

Manhole # S07AA2028MH

**Location** Address: **2809 GLEN AVE** Cross Street: **MERVILLE AVE**

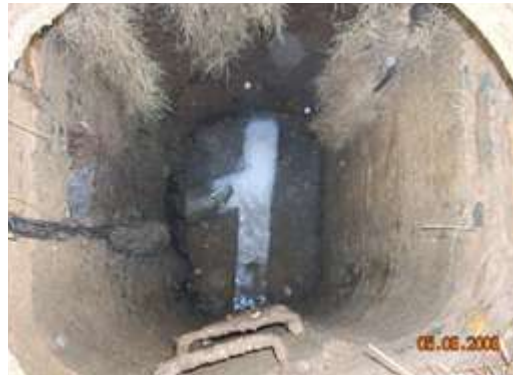
Top View

Corroded steps. Bench debris.

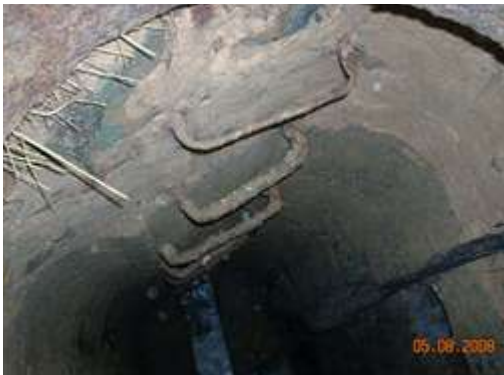
Defect

Corbel deterioration, root intrusion and infiltration.

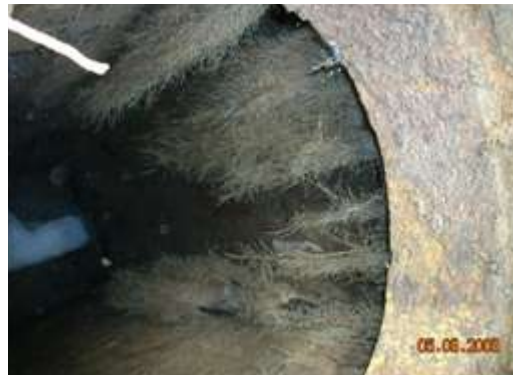
Defect

Frame leaks. Corbel root intrusion and infiltration.

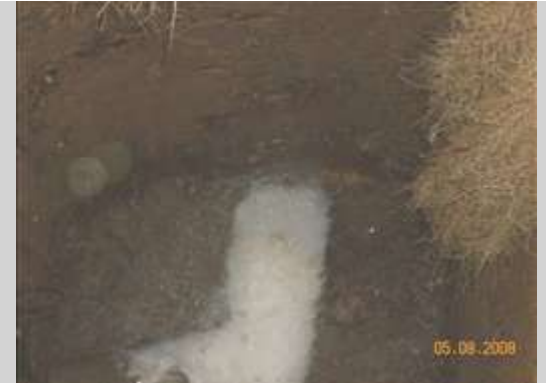
### 8 in. Circular Gravity Sewer Pipe Out @ 12 O'Clock

Barrel deterioration, root intrusion and infiltration.
